# An AI method for early detection of failures caused by corrosion on components during assembly - correlated to field failure analysis cases

Eyal Weiss<sup>1</sup>, Naveh Bartanah<sup>2</sup>, Alon Shachar<sup>2</sup>, Michael Dolkin<sup>2</sup>

<sup>1</sup>Cybord Ltd.

<sup>2</sup>Flex inc.

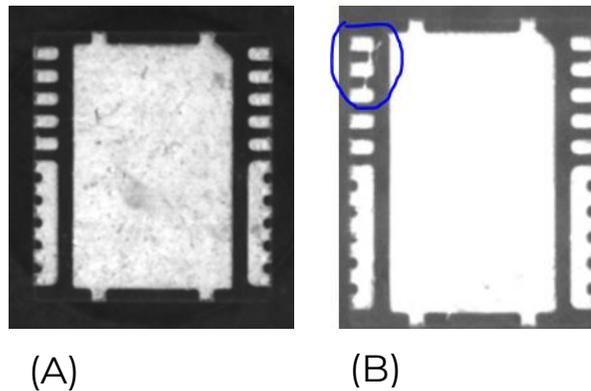
**Figure 1. VSON-12 Gate Drivers NexFET images captured by an ASM Siplace SX mounting machine and detected by the system with quality issues: (A) Corrosion, (B) Shorts.**

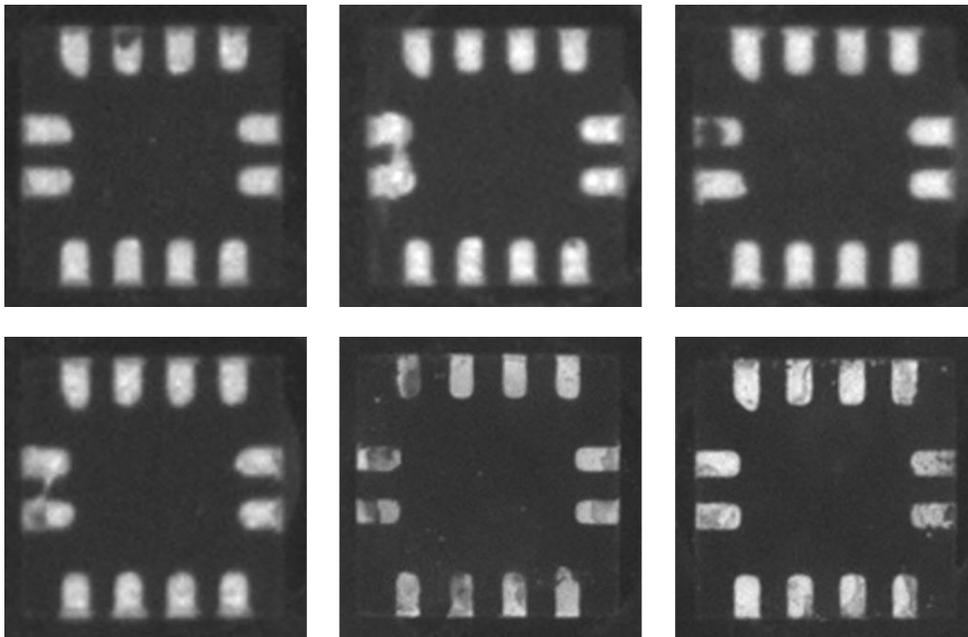
**Figure 2. QFN-12 Power switch images captured by an ASM Siplace SX mounting machine and detected by the system with quality issues: Terminal contamination, Corrosion, Shorts.**

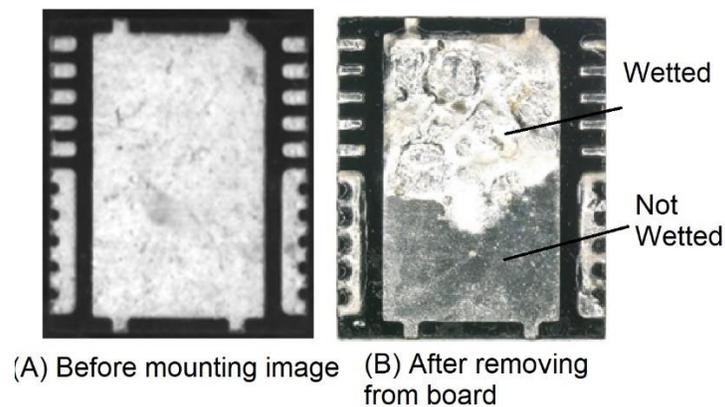
The VSON-12 is sensitive to moisture (MSL-2) and the failure is related to this sensitivity in a few different ways. The presence of corrosion on the soldering leads is an indication that the components were exposed to humidity during their storage and handling. This is because exposure to humidity results in corrosion growth on the exposed metallic parts on the component surface. In addition, the corrosion on the soldering leads is a failure mode by itself as it propagated over time into the package case. Third, the corrosion also affected the wettability of the soldering leads resulting in a partial bond. Figure 4(A) presents an image of the component taken by the SMT mounting camera during placement, evidence of corrosion is visible, and (B) an image of a failed component after removal from the board. In Figure 4(B) the top side of the image shows residues of the wetted area while the bottom side of the component appears to not contain paste, only a rough surface finish consistent with corrosion.

**Figure 4. VSON-12 (A) Image of a component taken by the SMT mounting camera during placement, evidence of corrosion visible, and (B) image of a failed component after removal from the board. In (B) the solder paste residue is visible on the top side, whereas on the bottom side, no evidence of wetting.**

As can be seen, the corrosion evidence was visible earlier in the image taken by the ASM vision system during the mounting (Figure 4(A), and Figure 1). The AI detection algorithm described in [7] detected corrosion evidence by analyzing the light reflectance from the soldering leads. The rough surface texture created by the corrosion on the leads was detected by the AI algorithm and cross-referenced with the failed units in the post-assembly tests where the failed units were also predicted as contaminated by the algorithm.

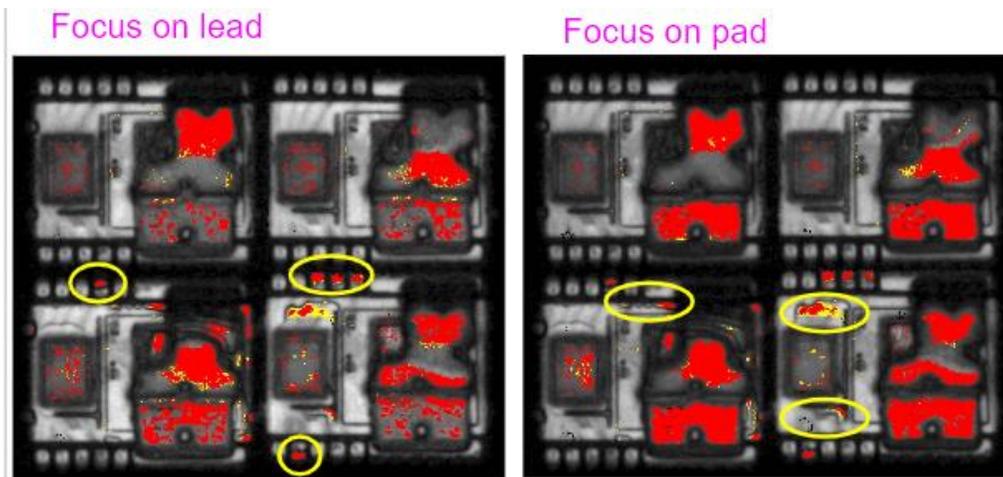
To verify the condition of the inner parts of the component a Scanning Acoustic Tomography (SAT) was performed. SAT is a method for analyzing materials by measuring the reflecting speed and energy of an ultrasonic wave which is transmitted through a material of a certain thickness. A C-scan inspection with horizontally x-sectioned 2D image after focus, and a thorough T-scan (see Figure 5). The delamination is presented in red.

**Figure 5. VSON-12 Scanning Acoustic Tomography image. The red color indicates delamination. The internal delamination appears on the inner part of the soldering leads.**

It is apparent from Figure 5 that there is degradation in the internal part of the component that attacked the chip's internal metallization. The surface corrosion on the leads (Figure 4) appears to have attacked the inside part as well. From Figure 4, it is apparent that the metallic pad did not have good wettability (only the top side here was wetted well), therefore the other side did not have good heat removal capability from the component to the board via the thermal pad. The failure's root cause is corrosion affecting wettability as well as propagating into the package case and causing internal delamination.

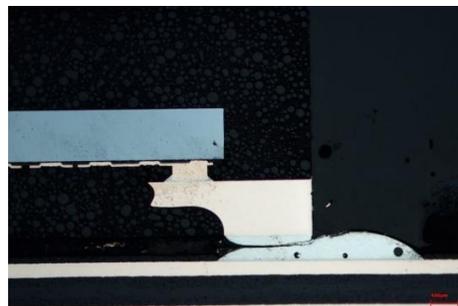
The QFN-12 is MSL-1 and is not sensitive to humidity. Nevertheless, the component was 6 years old at the time of the assembly and it was contaminated with severe corrosion and mold that affected the performance of the board. The components were inspected during the SMT process, flagged as contaminated with corrosion by the AI algorithm, and then failed in the post-assembly tests. The failure mode was shorts, solderability, and opens. Some 6-11% of the components suffered electrical failures.

The failure mode is evident from the cross-section of the component bond to the PCB (see Figure 6). Where a crack appears in the bond resulting in an open or a not reliable bond.

**Figure 6. QFN-12 solder bond with the PCB cross-section. A crack is visible between the lead and the paste.**

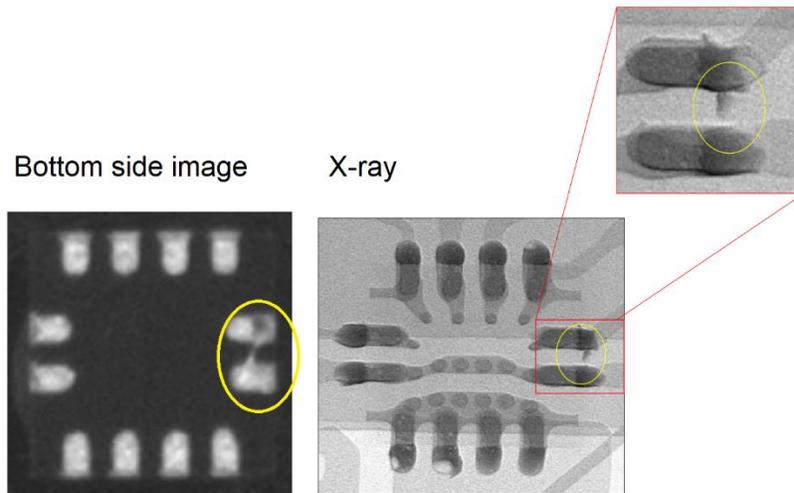
X-ray example analysis of the component did not reveal mounting issues except for a short. The short is also visible on the bottom-side image of the component taken before mounting. Shorts are easily detected automatically by the AI algorithm as there is a strong contrast between the light soldering leads and the dark component body. The X-ray shows a metallic short between the pads after the mounting on the PCB. It is impossible to say if the short was already in place before mounting or

only created during the mounting. By examining the bottom view image of the component before it was mounted on the PCB it becomes apparent that the short was there even before the assembly (Figure 7-left).

**Figure 7. QFN-12 Short is visible on the bottom view image taken by the SMT pick-and-place machine during mounting (left image), later to be also detected by the X-ray post-failure analysis. (right image)**

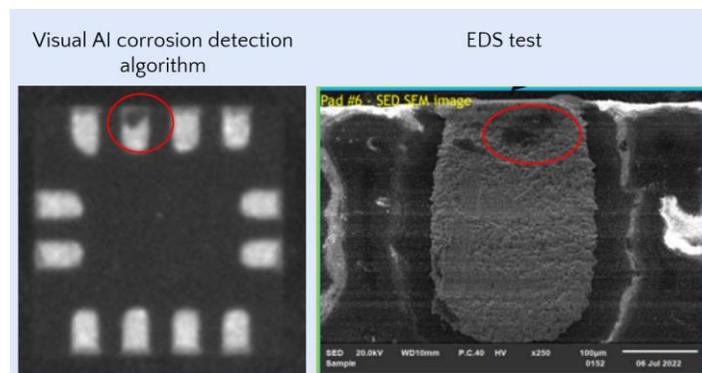
In addition to the X-ray, more analysis was made as the X-ray could not explain the massive failure rate. The failed boards were analyzed by SED-SEM microscopy. The analysis revealed contamination on the soldering leads as is visible in Figure 8 where QFN-12 SED SEM analysis example of a soldering pad with a black spot taken by the SMT pick-and-place machine during mounting (left image), compared to a microscopy image taken by the SEM-SED (right image). The black marks are visible on both the pre-assembly detection (Figure 8-left) and the SEM-SED post-failure analysis (Figure 8-right).

**Figure 8. QFN-12 SED SEM analysis example of a soldering pad with a black spot taken by the SMT pick-and-place machine during mounting (left image), compared to a microscopy image taken by the SEM-SED (right image).**

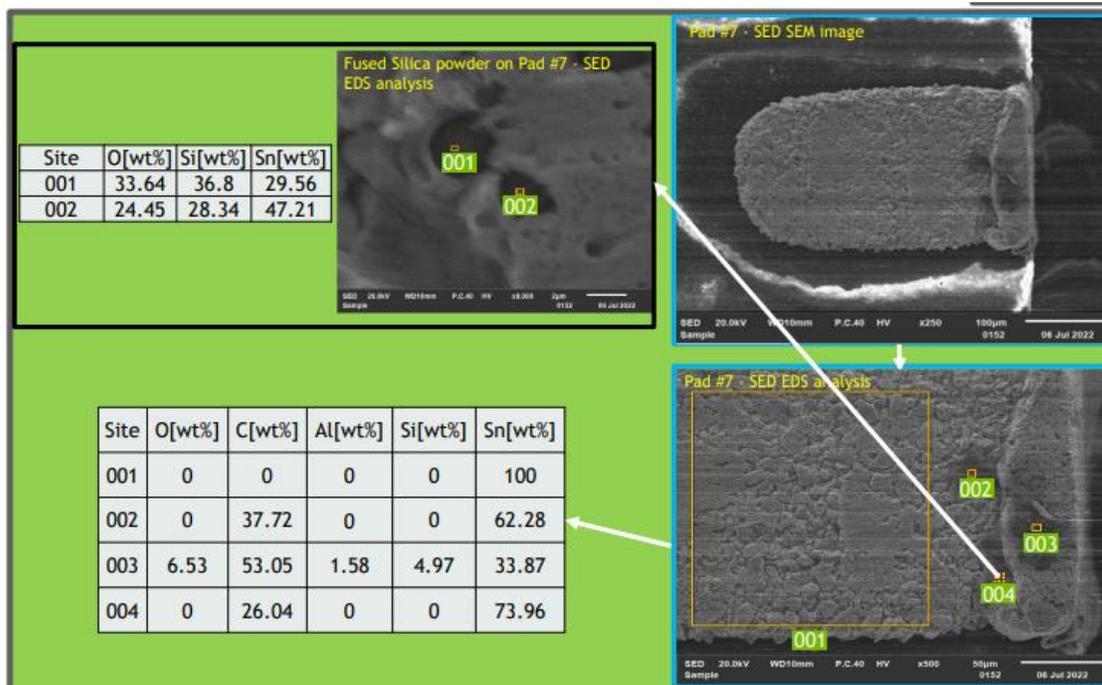
The SED analysis reveals that the contamination contains Oxygen, Silicon, and Carbon whereas clean lead doesn't contain any of these materials. Mold contains Silicon(Si), Carbon(C), and Oxygen(O), and oxidation (corrosion) contains Oxygen. From the microscopy images, it is apparent that the black marks are from mold and corrosion. Both are created by exposure to humidity under environmental stress, and both degrade the bond reliability and solderability (see Figure 9).

**Figure 9. QFN-12 SED SEM analysis example of a soldering pad with the black spot analyzed. The black spots contain Silicon(Si), Carbon(C), and Oxygen(O), which indicate the presence of mold and oxidation (corrosion). Both are the result of exposure to humidity and environmental stress.**

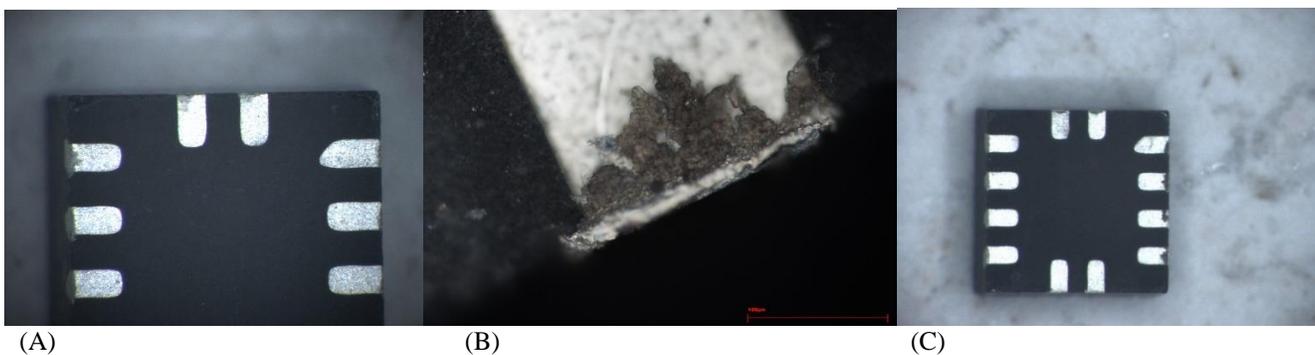
Further microscope inspection of components that did not go through production is presented in Figure 10. It shows the QFN-12 SED microscope images. (A, C): Rough surface finish caused by corrosion and evidence of old and corrosion at the edges of the leads. (B): zoom on mold at the edges of the soldering leads. As depicted, the surface finish, the corrosion marks, and the mold are also visible during the assembly by the SMT pick-and-place vision system.

**Figure 10. QFN-12 SED microscope images. (A, C): Rough surface finish caused by corrosion and evidence of old and corrosion at the edges of the leads. (B): zoom on mold at the edges of the soldering leads.**
