Preventing Corrosion-related Failures in Electronic Assembly: A Multi-case Study Analysis

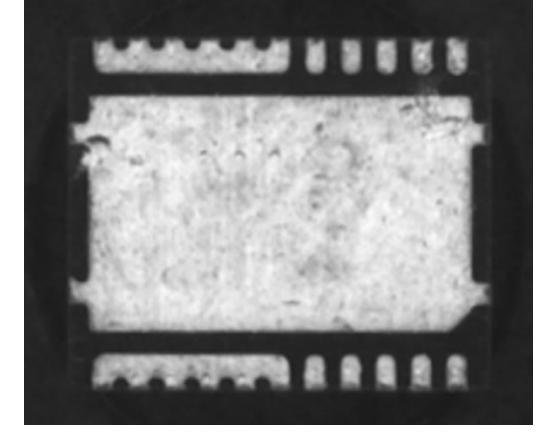
Electronic components are the most expensive part of the Bill of Materials (BOM) and are also the most common cause of failures in electronic products. Nevertheless, traditional production methods don't carry out systematic inspection, and seldom any tests are being made at all [1]. This is even though electronic components are the means of most of the failures in electronic products [2]. Unsafe components are more common today because of the electronic components shortage that has made the supply chain more complex and vulnerable to fraudulent falsifications [3]. As a result, components that were obtained from nonreliable sources, recycled components, components that were

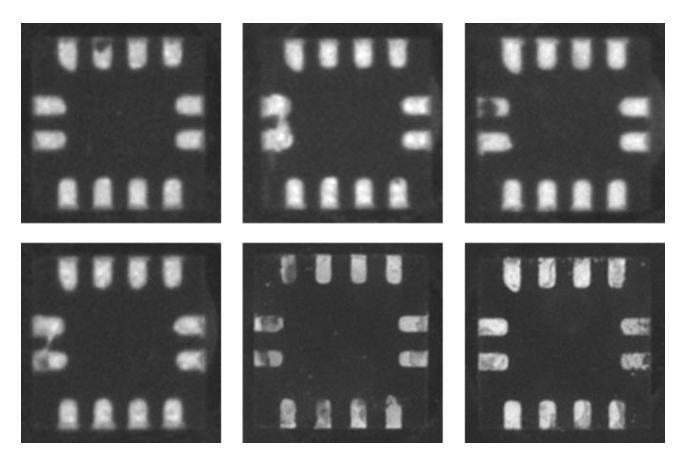
Fig. 2. QFN-12 Power switch images captured by an ASM Siplace SX mounting machine and detected by Cybord.ai system with quality issues: Terminal contamination, Corrosion, Shorts.

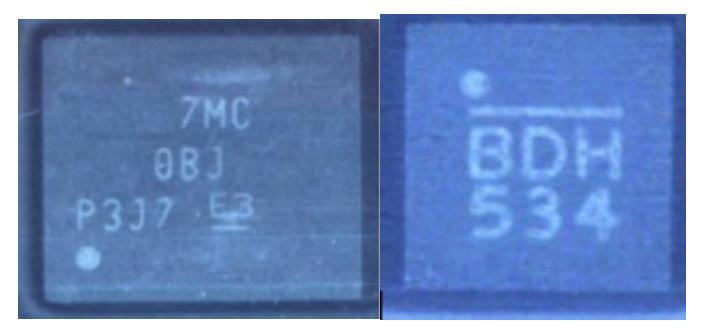
Fig. 3. VSON-12 (left), and QFN-12 (right) images were taken from the top side by an authentication system (an image of similar components from a different production batch).

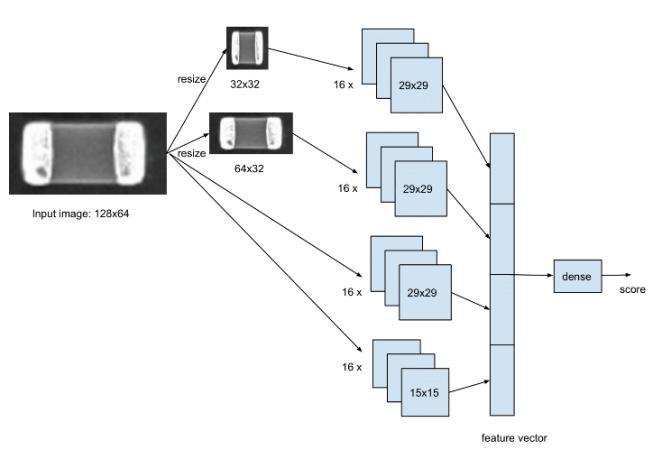
To address these challenges, we presented a new network architecture [26] that is tailored to handle defects (Fig. 4). Instead of using the serial architecture used in popular image classification models, we propose using a set of filters with different window sizes that are concatenated in parallel. Each filter is designed to detect a type of defective region in the component images and generate a feature that indicates the likelihood of the image containing such defects.

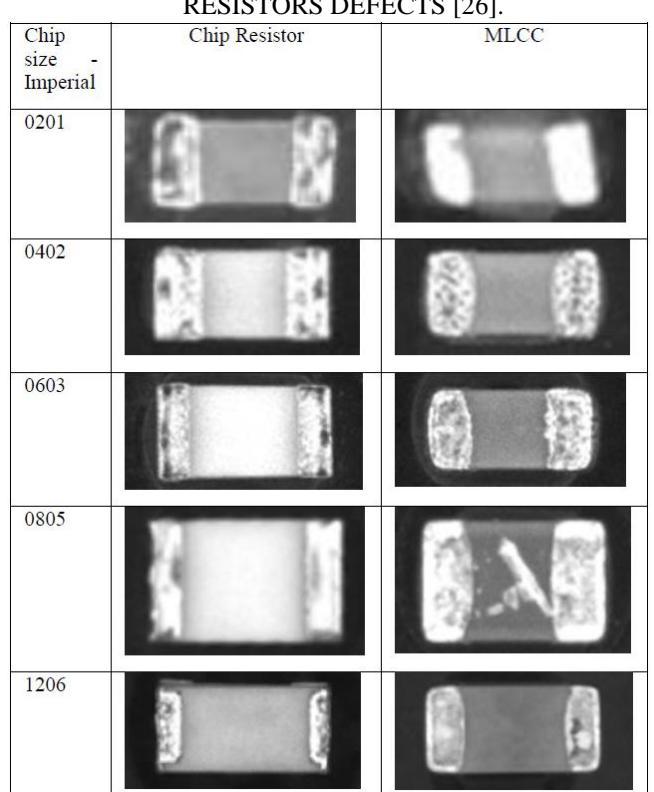
TABLE II. EXAMPLE IMAGES OF MLCC AND CHIP RESISTORS DEFECTS [26].

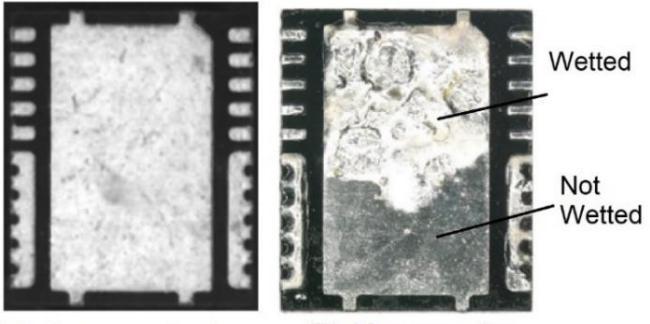
(A) Before mounting image (B) After removing from board

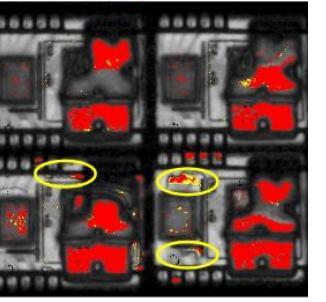
Fig. 6. VSON-12 Scanning Acoustic Tomography image. The red color indicates delamination. The internal delamination appears on the inner part of the soldering terminations.

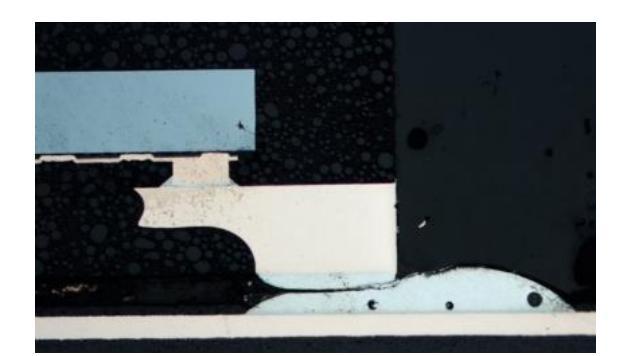
Fig. 7. QFN-12 solder bond with the PCB cross-section. A crack is visible between the termination and the paste.

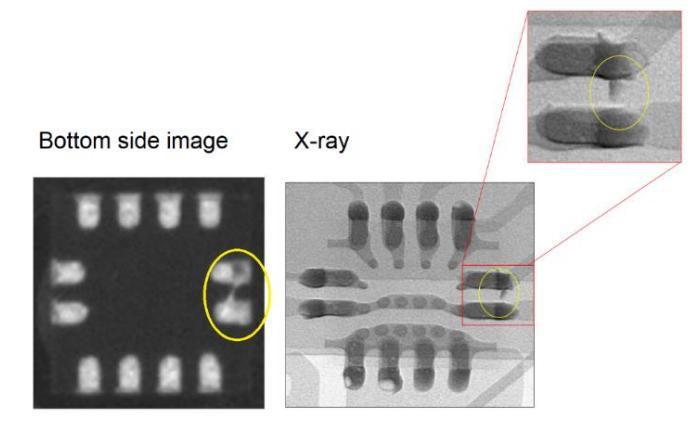
Fig. 8. QFN-12 Short is visible on the bottom view image taken by the SMT pick-and-place machine during mounting (left image), later to be also detected by the X-ray post-failure analysis. (Right image).

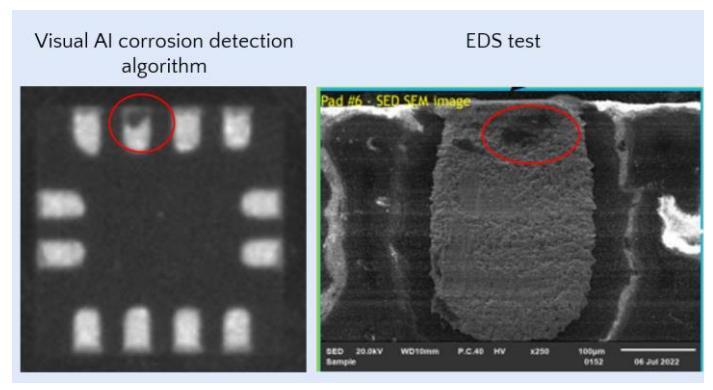
Fig. 9. QFN-12 SED SEM analysis example of a soldering pad with a black spot taken by the SMT pick-and-place machine during mounting (left image), compared to a microscopy image taken by the SEM-SED (right image).

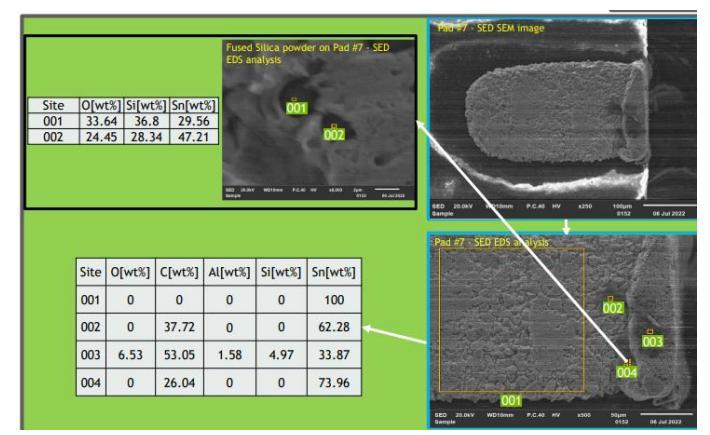
Fig. 10. QFN-12 SED SEM analysis example of a soldering pad with the black spot analyzed. The black spots contain Silicon (Si), Carbon (C), and Oxygen (O), which indicate the presence of mold and oxidation. Both are the result of exposure to humidity and environmental stress.

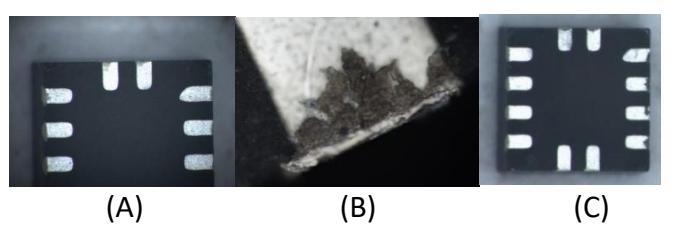
Fig. 11. QFN-12 SED microscope images. (A, C): Rough surface finish caused by corrosion and evidence of old and corrosion at the edges of the terminations. (B): zoom on mold at the edges of the soldering terminations.
