Preventing Corrosion-related Failures in Electronic Assembly: A Multi-case Study Analysis

E. Weiss

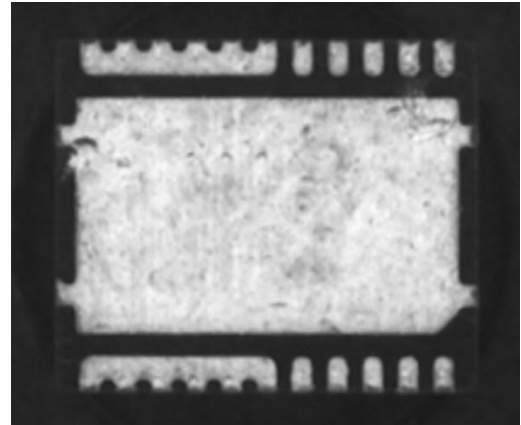
Fig. 1. VSON-12 Gate Drivers NexFET images captured by an ASM Siplace SX mounting machine and detected by Cybord.ai system with quality issues.

The method was applied to real assembled components. We present examples of electronic components VSON-12 Gate Drivers NexFET in 12-VSON-CLIP package (see Fig. 1), and QFN-12 Power switch (see Fig. 2) with corrosion that was detected by the presented method. The failure analysis of these components was performed using X-ray analysis, scanning electron microscopy (SEM) and energy-dispersive spectroscopy (EDS) microscopy, and visible light microscopy. The analysis demonstrates a clear correlation between the AI-detected corrosion and the corrosion and failure mode identified in the failure analysis. The AI method was then calibrated to detect potential failures that may result in future failures.

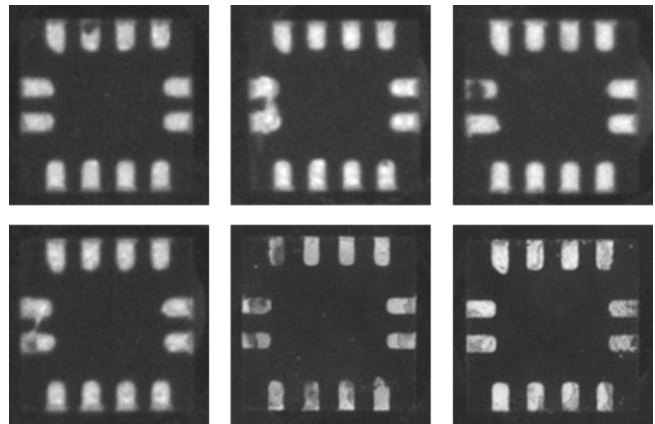
Fig. 2. QFN-12 Power switch images captured by an ASM Siplace SX mounting machine and detected by Cybord.ai system with quality issues: Terminal contamination, Corrosion, Shorts.

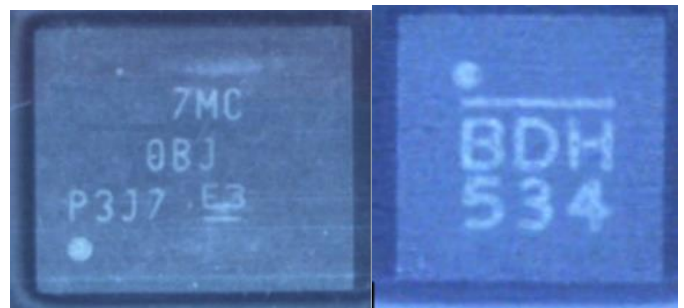
Fig. 3. VSON-12 (left), and QFN-12 (right) images were taken from the top side by an authentication system (an image of similar components from a different production batch).

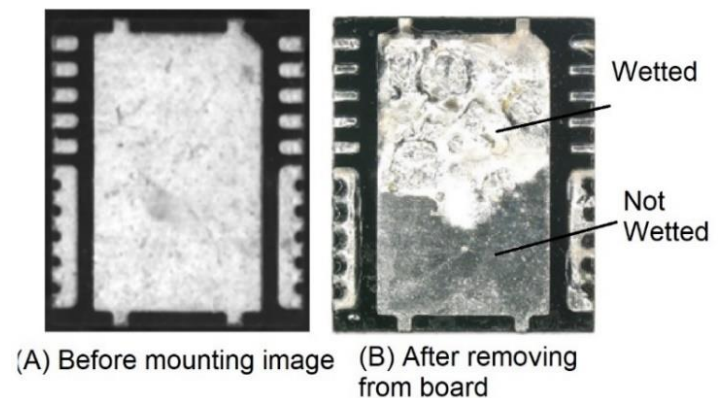
Fig. 4. VSON-12 (A) Image of a component taken by the SMT mounting camera during placement, evidence of corrosion visible, and (B) image of a failed component after removal from the board. In (B) the solder paste residue is visible on the top side, whereas on the bottom side, no evidence of wetting.

from the board. The top side of the image in Fig. 4(B) shows residues of the wetted area, while the bottom side of the component appears to not contain paste, only a rough surface finish consistent with corrosion.

In this section, we present a failure case of VSON-12 Gate Drivers NexFET electronic components, which are sensitive to moisture with a Moisture Sensitivity Level (MSL) of 2. The failure is attributed to multiple factors, including exposure to humidity during storage and handling, resulting in the growth of corrosion on the exposed metallic parts of the component surface. Additionally, the presence of corrosion on the soldering leads acts as a failure mode in itself, as it propagates over time and affects the package case. Furthermore, the corrosion also affects the soldering leads' wettability, resulting in a partial bond. Fig. 4(A) shows an image of the component taken by the SMT mounting camera during placement, which illustrates the visible evidence of corrosion, and Fig. 4(B) presents an image of a failed component after removal

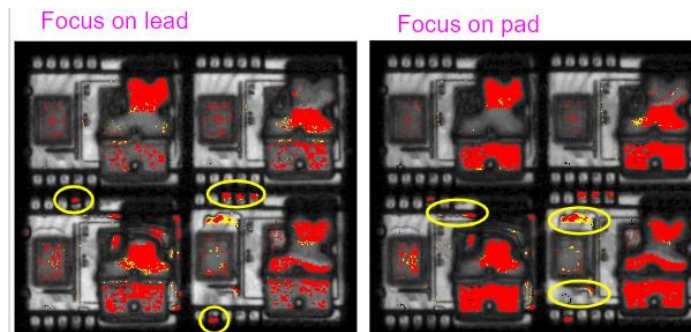
To further understand the condition of the inner parts of the component, a Scanning Acoustic Tomography (SAT) analysis was performed. SAT is a non-destructive method for evaluating the structural integrity of materials by measuring the speed and energy of an ultrasonic wave as it travels through a material of a certain thickness. The analysis included a C-scan inspection with a horizontally x-sectioned 2D image after focus and a detailed T-scan (as seen in Fig. 5). The results of the SAT analysis revealed delamination, which is presented in red in the image.

The results of the SAT analysis shown in Fig. 5 clearly indicate that there is a degradation in the internal structure of the component, specifically in the chip's internal metallization. This degradation is likely caused by the corrosion present on the leads as seen in Fig. 4. The poor wettability of the metallic pad, as evidenced by the lack of paste on the bottom side of the component in Fig. 4, also contributed to the failure. This lack of proper wettability resulted in poor heat removal capability from the component to the board via the thermal pad. In summary, the root cause of the failure is the corrosion which affected both the wettability and propagated into the package case, causing internal delamination.

Fig. 5. VSON-12 Scanning Acoustic Tomography image. The red color indicates delamination. The internal delamination appears on the inner part of the soldering leads.

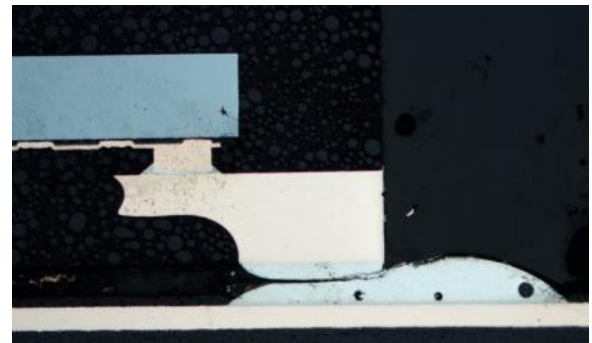
Fig. 6. QFN-12 solder bond with the PCB cross-section. A crack is visible between the lead and the paste.

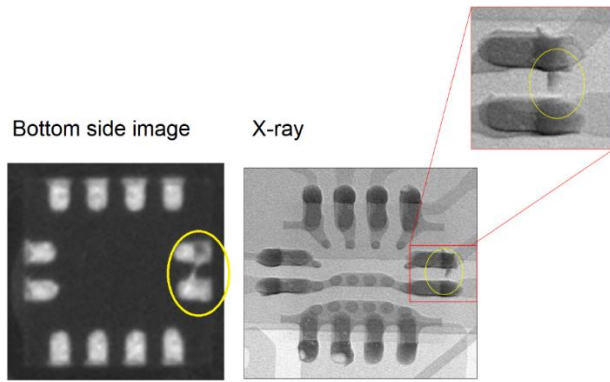
X-ray example analysis of the component did not reveal mounting issues except for a short. The short is also visible on the bottom-side image of the component taken before mounting. Shorts are easily detected automatically by the AI algorithm as there is a strong contrast between the light soldering leads and the dark component body. The X-ray shows a metallic short between the pads after the mounting on the PCB. It is impossible to say if the short was already in place before mounting or only created during the mounting. By examining the bottom view image of the component before it was mounted on the PCB it becomes apparent that the short was there even before the assembly (Fig. 7-left).

Fig. 7. QFN-12 Short is visible on the bottom view image taken by the SMT pick-and-place machine during mounting (left image), later to be also detected by the X-ray post-failure analysis. (Right image).

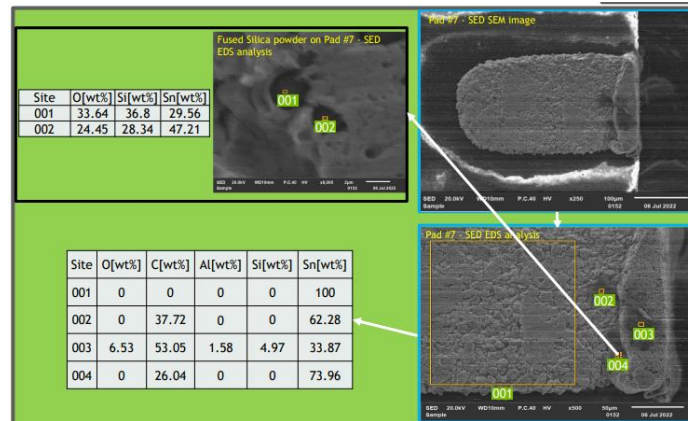
The SED analysis reveals that the contamination contains Oxygen, Silicon, and Carbon whereas clean lead doesn't contain any of these materials. Mold contains Silicon (Si), Carbon(C), and Oxygen(O), and oxidation (corrosion) contains Oxygen. From the microscopy images, it is apparent that the black marks are from mold and corrosion. Both are created by exposure to humidity under environmental stress, and both degrade the bond reliability and solderability (see Fig. 9).

Fig. 9. QFN-12 SED SEM analysis example of a soldering pad with the black spot analyzed. The black spots contain Silicon (Si), Carbon (C), and Oxygen (O), which indicate the presence of mold and oxidation. Both are the result of exposure to humidity and environmental stress.

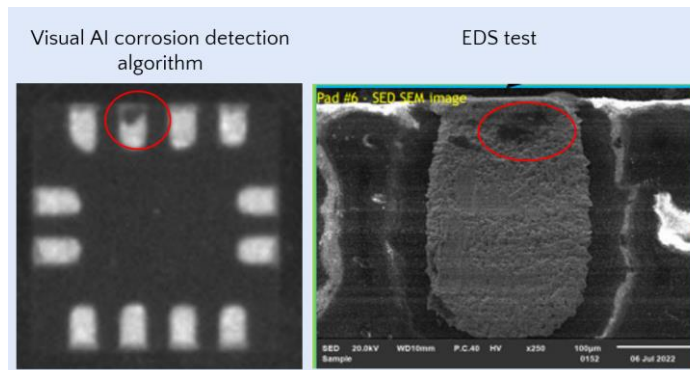
In addition to the X-ray, more analysis was made as the X-ray could not explain the massive failure rate. The failed boards were analyzed by SED-SEM microscopy. The analysis revealed contamination on the soldering leads as is visible in Fig. 8 where QFN-12 SED SEM analysis example of a soldering pad with a black spot taken by the SMT pick-and-place machine during mounting (left image), compared to a microscopy image taken by the SEM-SED (right image). The black marks are visible on both the pre-assembly Cybord.ai detection (Fig. 8-left) and the SEM-SED post-failure analysis (Fig. 8-right).

Fig. 8. QFN-12 SED SEM analysis example of a soldering pad with a black spot taken by the SMT pick-and-place machine during mounting (left image), compared to a microscopy image taken by the SEM-SED (right image).

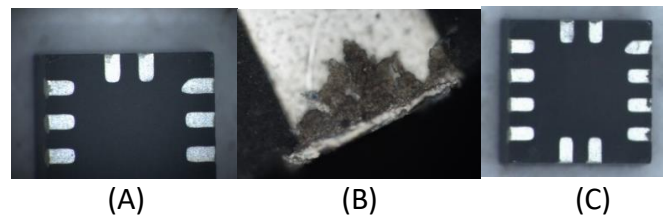
Further microscope inspection of components that did not go through production is presented in Fig. 10. It shows the QFN-12 SED microscope images. (A, C): Rough surface finish caused by corrosion and evidence of old and corrosion at the edges of the leads. (B): zoom on mold at the edges of the soldering leads. As depicted, the surface finish, the corrosion marks, and the mold are also visible during the assembly by the SMT pick-and-place vision system.

Fig. 10. QFN-12 SED microscope images. (A, C): Rough surface finish caused by corrosion and evidence of old and corrosion at the edges of the leads. (B): zoom on mold at the edges of the soldering leads.
