# An AI method for early detection of failures caused by corrosion on components during assembly - correlated to field failure analysis cases

Eyal Weiss<sup>1</sup>, Naveh Bartanah<sup>2</sup>, Alon Shachar<sup>2</sup>, Michael Dolkin<sup>2</sup>

<sup>1</sup>Cybord Ltd.

<sup>2</sup>Flex inc.

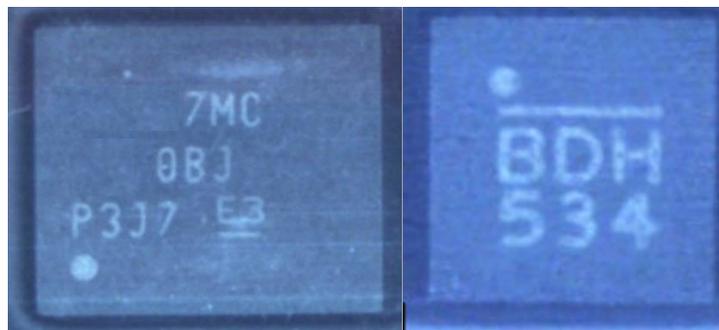
**Figure 3. VSON-12 (left), and QFN-12 (right) images were taken from the top side by a reel-to-reel authentication system (an image of similar components from a different production batch).**

Case 1: VSON-12 Gate Drivers NexFET (see Figures 1, and 3 left) has moisture sensitivity level (MSL) 2, hence it is sensitive to moisture and must be kept according to standards in vacuum during storage and handling.

Case 2: QFN-12 Power switch (see Figures 2, and 3 right) is MSL 1.
